# Crockery Lake Evaluation Study and Restoration Plan Ottawa County, Michigan

**Provided for: Crockery Lake Association**

**Prepared by: Restorative Lake Sciences  
Jennifer L. Jermalowicz-Jones, PhD, CLP  
Water Resources Director  
18406 West Spring Lake Road  
Spring Lake, Michigan 49456  
[www.restorativelakesciences.com](http://www.restorativelakesciences.com)**

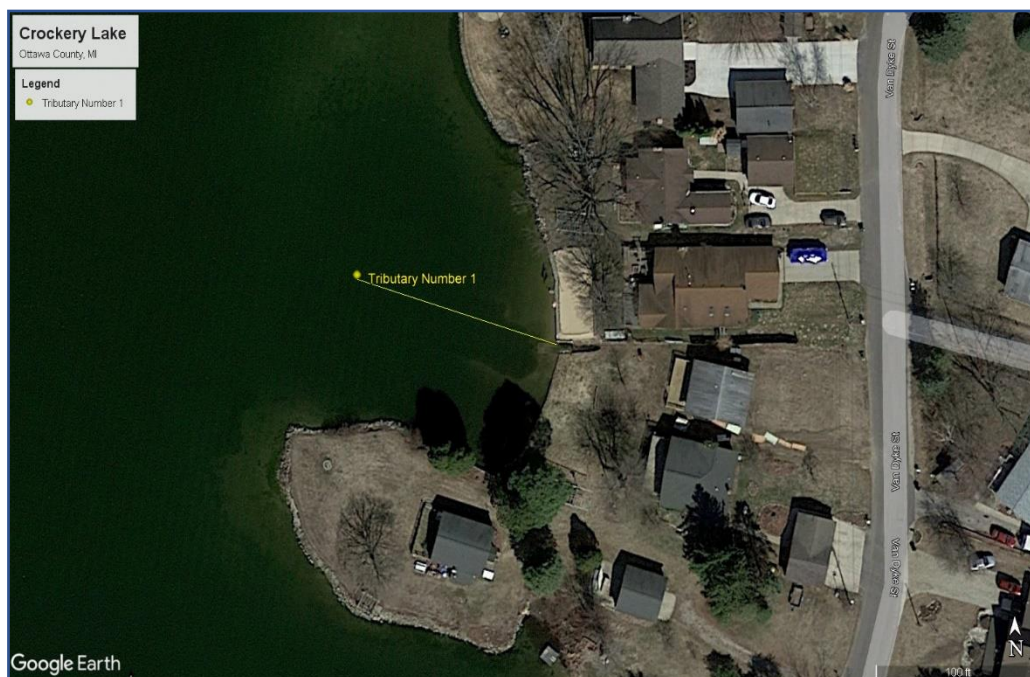
**Figure 8. CSA #1 draining into Crockery Lake (east side). This drain is approximately 5-6' feet in width**

Critical Source Areas (CSA's) for Crockery Lake were determined based on characteristics that would likely contribute nutrient or sediment loads to Crockery Lake which includes major drains. A total of 4 CSA's were found in the immediate watershed entering Crockery Lake and are shown in Figures 8-11. In addition, it is important to remember that during high rainfall periods, wetlands around the lake may act as a source, rather than a sink, for nutrients that may enter the lake. This is a natural process that does not have a man-made solution.

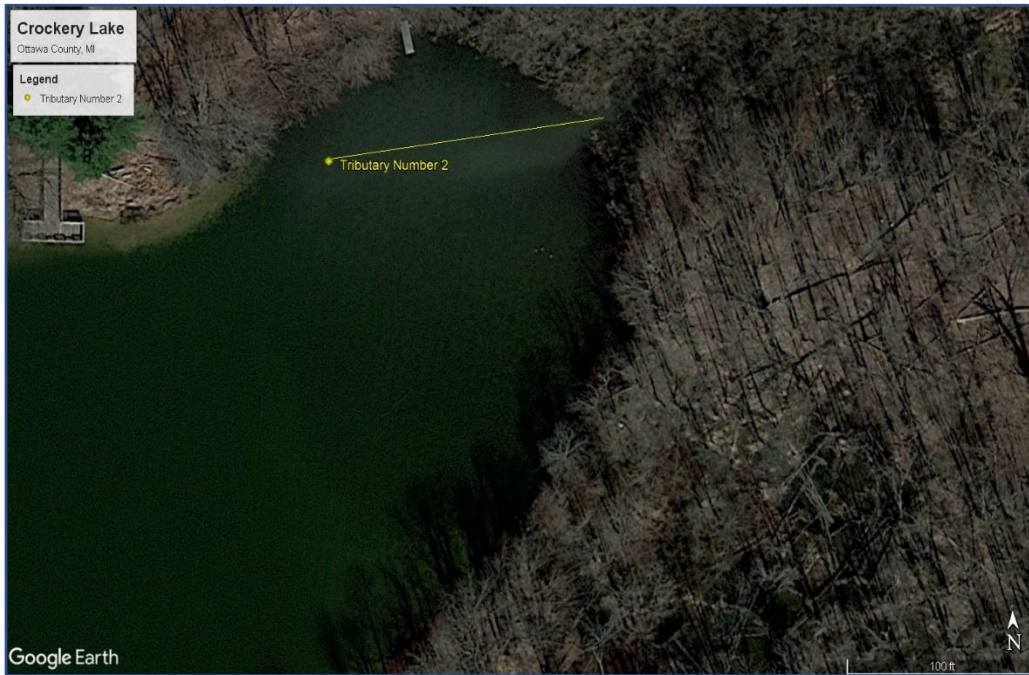
**Figure 9. CSA #2 draining into Crockery lake (northeast) near the swamp. This drain is approximately 8-10' in width.**

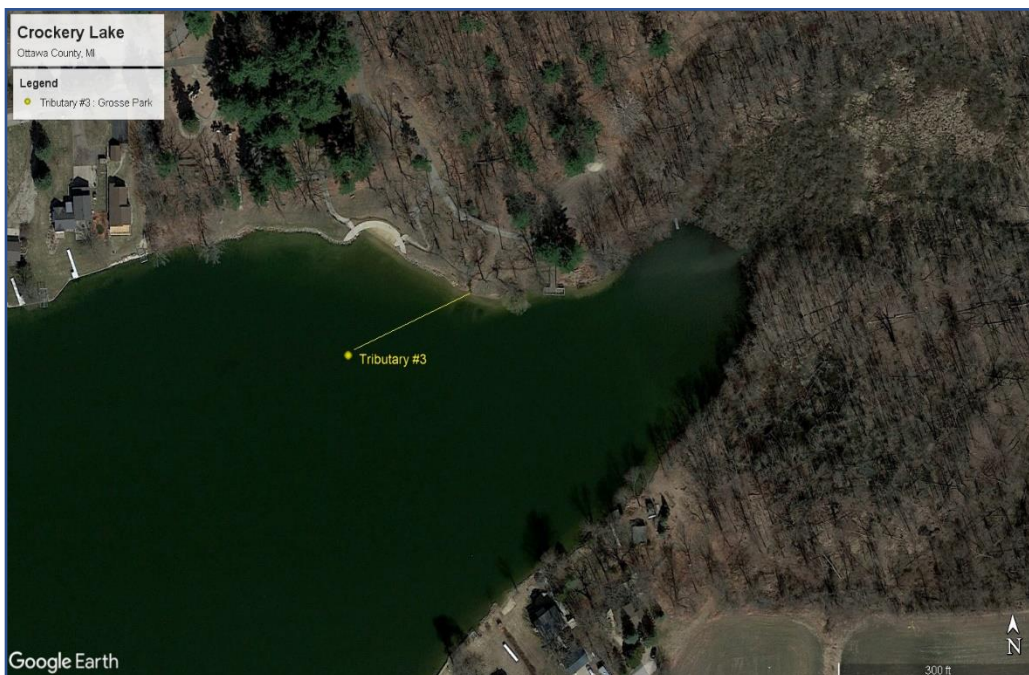
**Figure 10. CSA #3 draining into Crockery Lake (north) near Grosse Park. This drain is approximately 4-6' in width near the lake.**

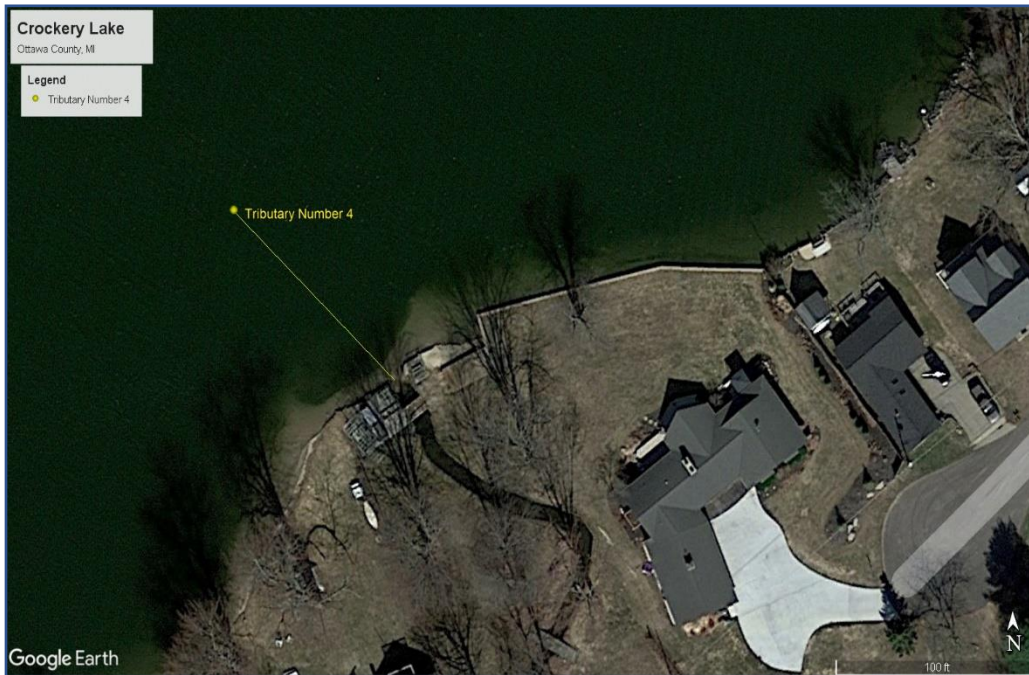
**Figure 11. CSA #4 draining into Crockery Lake (by foot bridge). This drain is approximately 10-12' in width.**

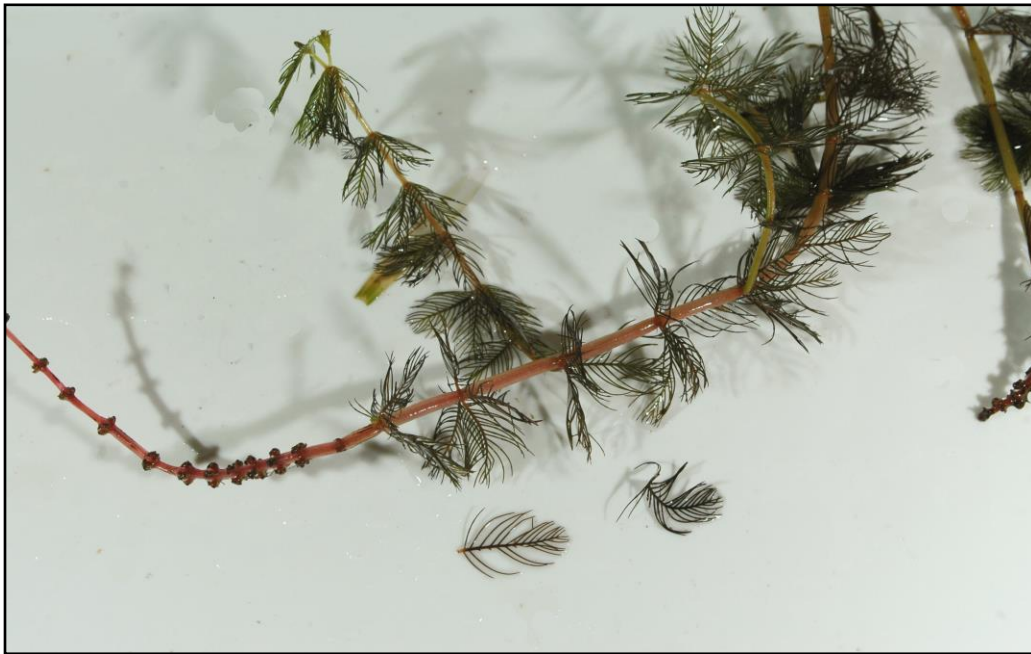
**Figure 32. Hybrid Eurasian Watermilfoil plant with seed head and fragments (©RLS).**

Eurasian Watermilfoil was found to occupy 2.5 acres of surface area in Crockery Lake during the May 29, 2024 survey. Eurasian Watermilfoil growth in Crockery Lake is capable of producing dense surface canopies and may increase significantly if not managed. Figure 34 shows the distribution of milfoil throughout the lake. Table 22 shows all of the various invasives found and their relative abundance in the lake.

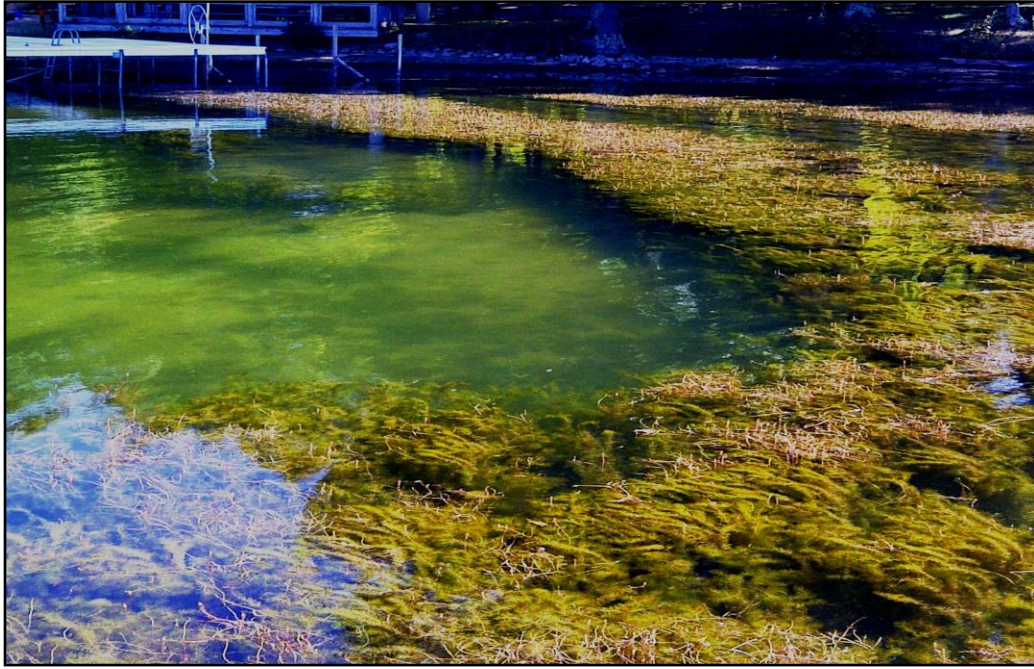
**Figure 33. Hybrid Eurasian Watermilfoil Canopy on an inland lake (©RLS).**

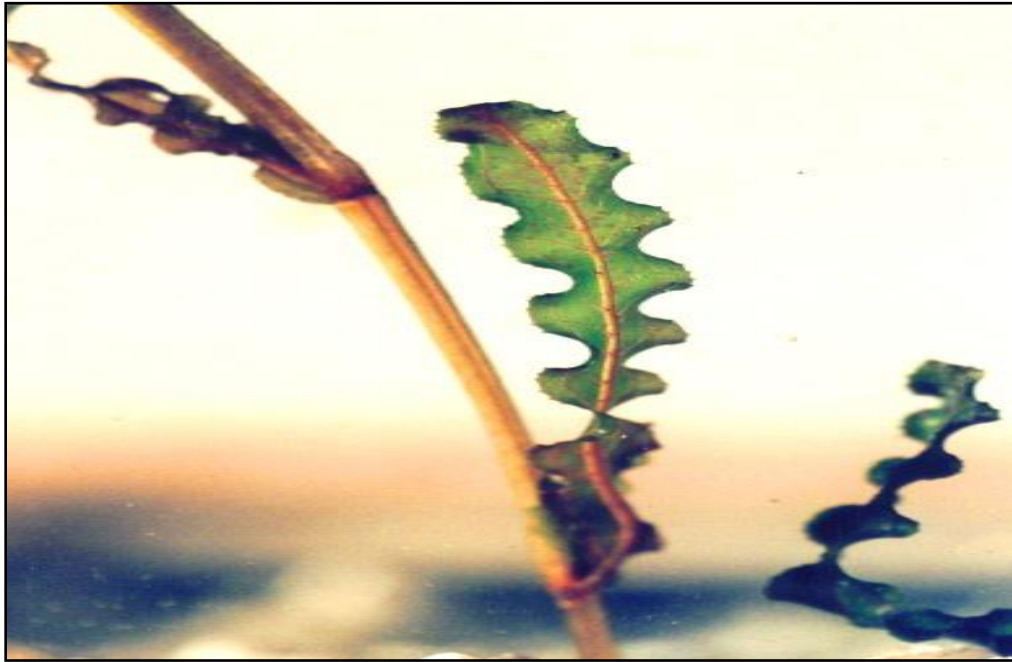
Curly-leaf Pondweed (*Potamogeton crispus*; Figure 35) is an exotic, submersed, rooted aquatic plant that was introduced into the United States in 1807 but was abundant by the early 1900's. It is easily distinguished from other native pondweeds by its wavy leaf margins. It grows early in the spring and as a result may prevent other favorable native aquatic species from germinating. The plant reproduces by the formation of fruiting structures called turions. It does not reproduce by fragmentation as invasive watermilfoil does; however, the turions may be deposited in the lake sediment and germinate in following seasons. Curly-leaf Pondweed is a pioneering aquatic plant species and specializes in colonizing disturbed habitats. It is highly invasive in aquatic ecosystems with low biodiversity and unique sediment characteristics. Approximately 5.1 acres of Curly-leaf pondweed were present during the May 29, 2024 survey (Figure 36). It is unlikely that this plant will be problematic later in the summer given its natural tendency to die back in mid-summer.

Figure 35. Curly-leaf Pondweed (©RLS).

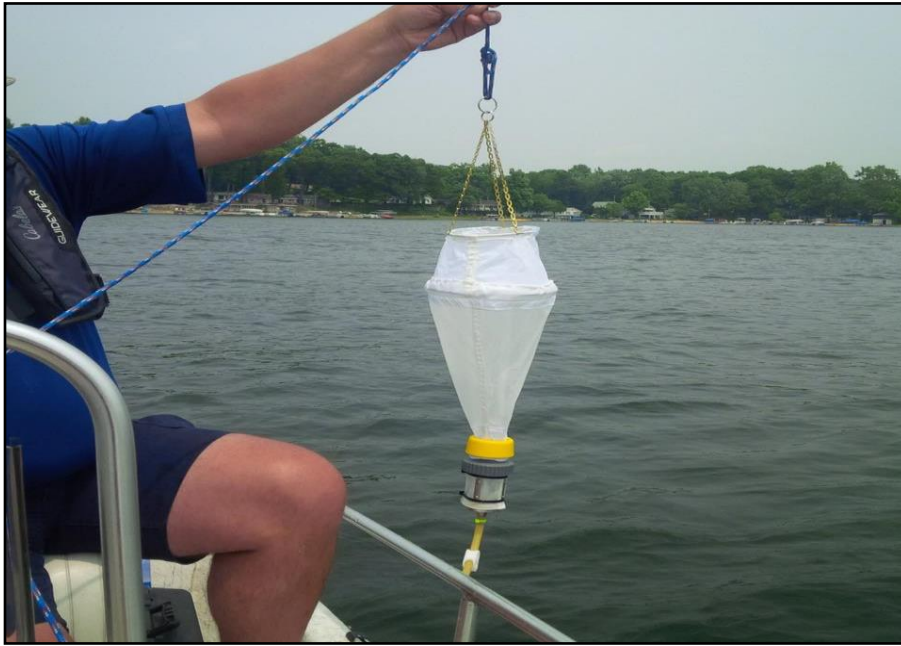
**Figure 37. A zooplankton collection tow net (©RLS).**

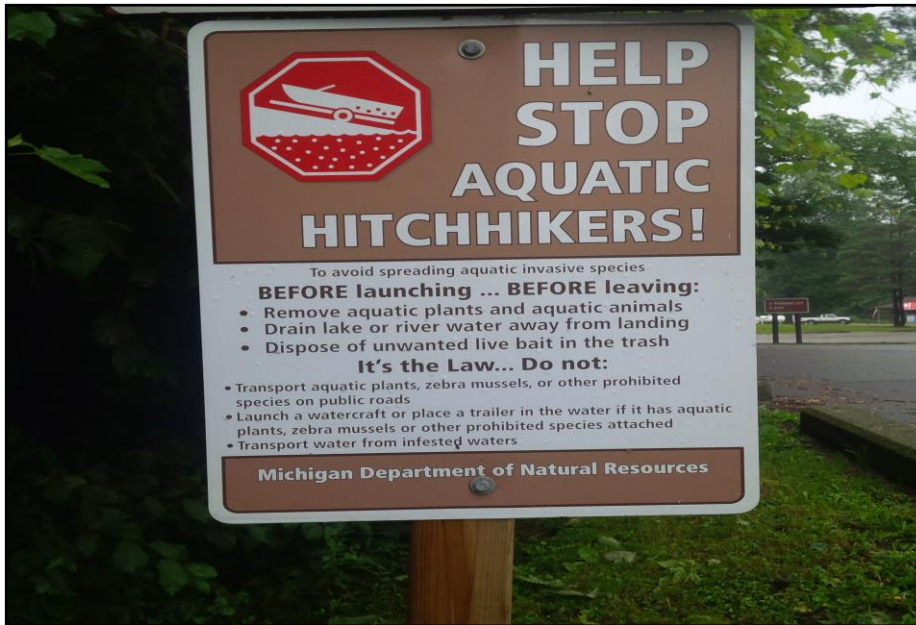
Figure 39. An aquatic invasive prevention sign for public access sites.

The first ingredient to successful prevention of unwanted transfers of exotic species to Crockery Lake is awareness and education (Figures 39 and 40). The majority of the exotic species of concern have been listed in this report. Other exotic species on the move could be introduced to the riparians around Crockery Lake through the use of a professionally developed educational newsletter distributed to all lake residents.

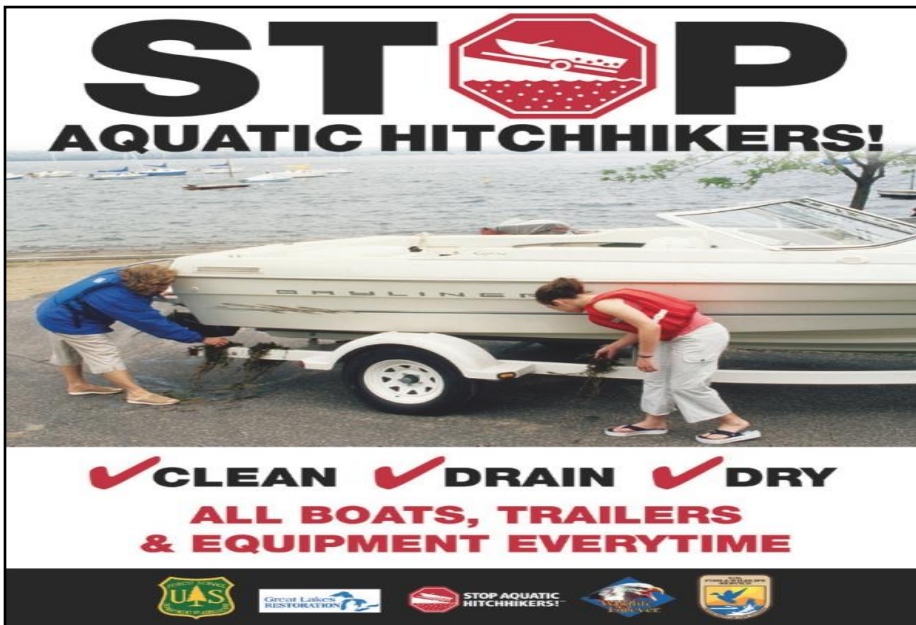
Figure 40. An aquatic invasive prevention sign for public access sites.

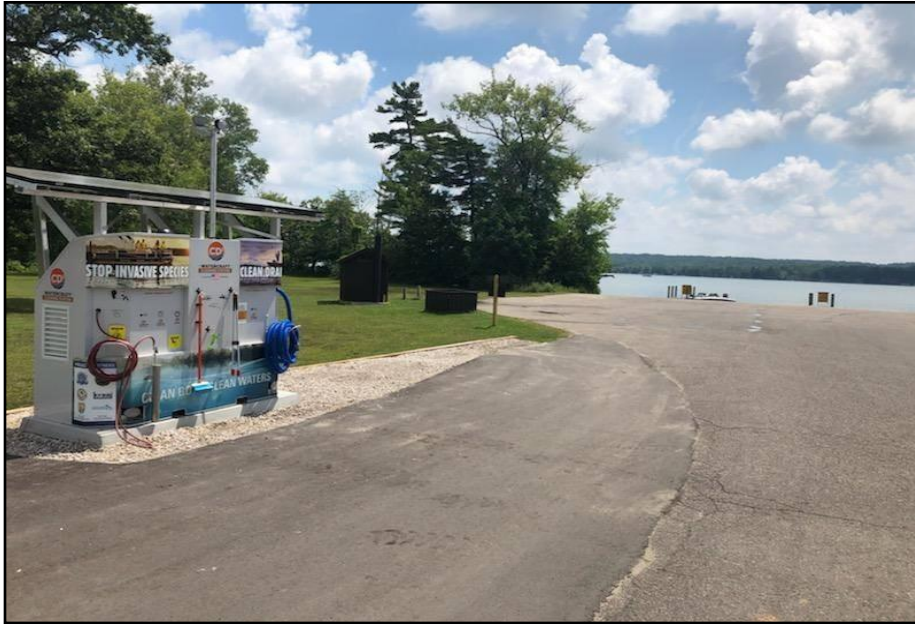
**Figure 41. A public boat washing station for boat access sites.**

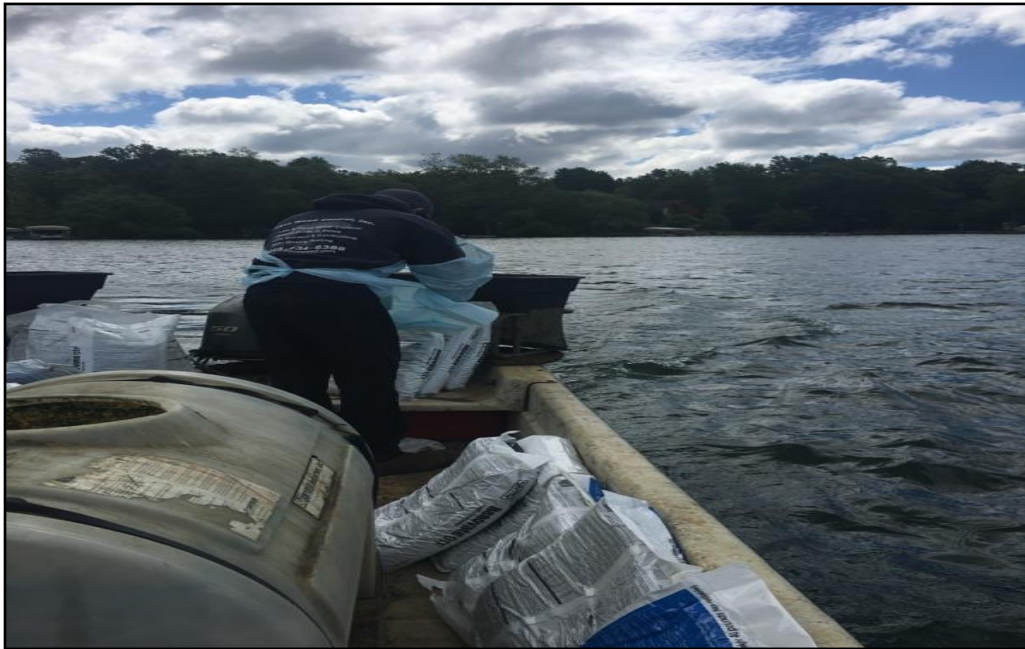
**Figure 43. A boat used to apply aquatic herbicides in inland lakes (©RLS).**

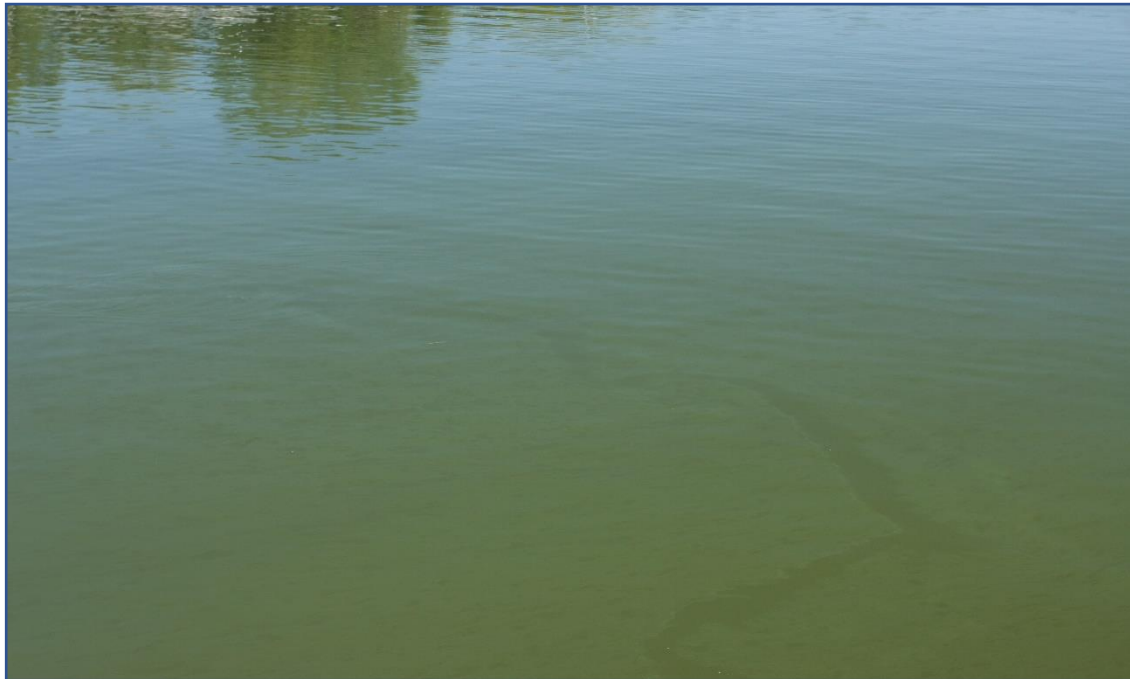
Algaecides should only be used on green algal blooms since many treatments can exacerbate blue-green algae blooms. The blue-green algae, *Microcystis* sp. was the most prevalent algae in the lake, which is an indicator of poor water quality (Figure 44). *Microcystis* colonies are a few micrometers in diameter and are evenly distributed throughout a gelatinous matrix. Younger colonies are spherical and older ones are more irregularly shaped. There are numerous gas vesicles, and the algae can thrive at the surface with minimal photo-degradation (breaking down) by the sun. When the sunlight is excessive, the algae can break down and release toxins and lower the dissolved oxygen in the water column. The algae are the only type known to fix nitrogen gas into ammonia for growth. *Microcystis* has also been shown to overwinter in lake sediments (Fallon et al., 1981). In addition, it may thrive in a mucilage layer with sediment bacteria that can release phosphorus under anaerobic conditions (Brunberg, 1995). They assume a high volume in the water column (Reynolds, 1984) compared to diatoms and other single-celled green algae.

**Figure 44. A surface scum of blue-green algae on Crockery Lake (July, 2024).**

The blue-green algae have been on the planet nearly 2.15 billion years and have assumed strong adaptation mechanisms for survival. In general, calm surface conditions will facilitate enhanced growth of this type of algae since downward transport is reduced. *Microcystis* may also be toxic to zooplankton such as *Daphnia* which was a zooplankton present in Crockery Lake and in most lakes (Nizan et al., 1986). Without adequate grazers to reduce algae, especially blue greens, the blue-green population will continue to increase and create negative impacts to water bodies.

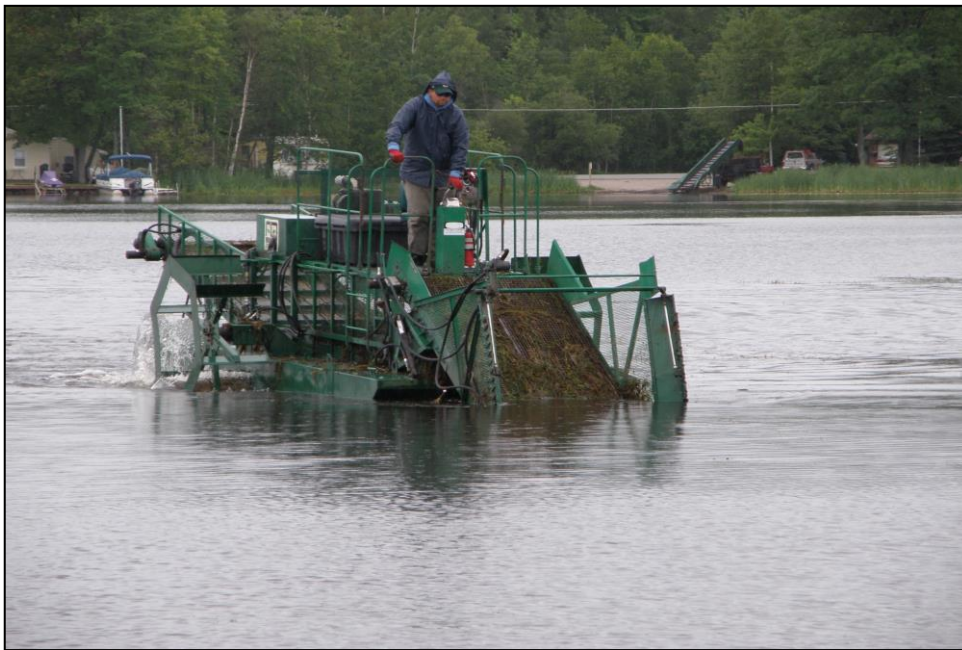
**Figure 45. A mechanical harvester used to remove aquatic plants (©RLS).**

Mechanical harvesting involves the physical removal of nuisance aquatic vegetation with the use of a mechanical harvesting machine (Figure 45). The mechanical harvester collects numerous loads of aquatic plants as they are cut near the lake bottom. The plants are off-loaded onto a conveyor and then into a dump truck. Harvested plants are then taken to an offsite landfill or farm where they can be used as fertilizer. Mechanical harvesting is preferred over chemical herbicides when primarily native aquatic plants exist, or when excessive amounts of plant biomass need to be removed. Mechanical harvesting is usually not recommended for the removal of Eurasian Watermilfoil since the plant may fragment when cut and re-grow on the lake bottom. It may be considered in future years for Crockery Lake if the milfoil is not present and the submersed aquatic vegetation grows to nuisance levels and the residents desire a biomass removal technique that does not consist of the use of contact herbicides.

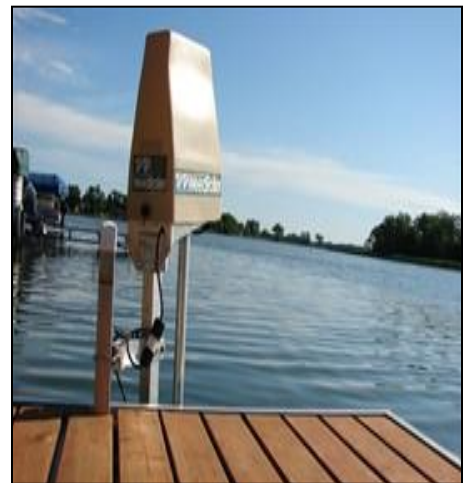
**Figure 47. A Weed Roller.**

Both methods are useful in recreational lakes such as Crockery Lake and work best in beach areas and near docks to reduce nuisance aquatic vegetation growth if it becomes prevalent in future years.

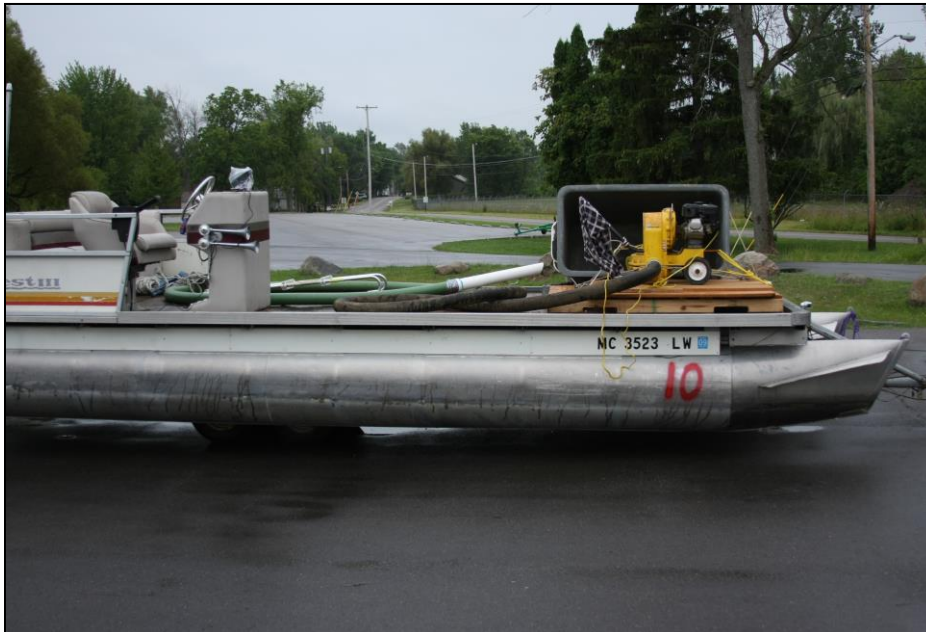
**Figure 48. A DASH boat used for aquatic plant removal (©RLS).**

Furthermore, this activity may cause re-suspension of sediments (Nayar et al., 2007) which may lead to increased turbidity and reduced clarity of the water. This method is a sustainable option for removal of plant beds in beach areas and areas where herbicide treatments may be restricted. It is also optimal for areas of dense lily pads that are impeding navigation and recreational activities.

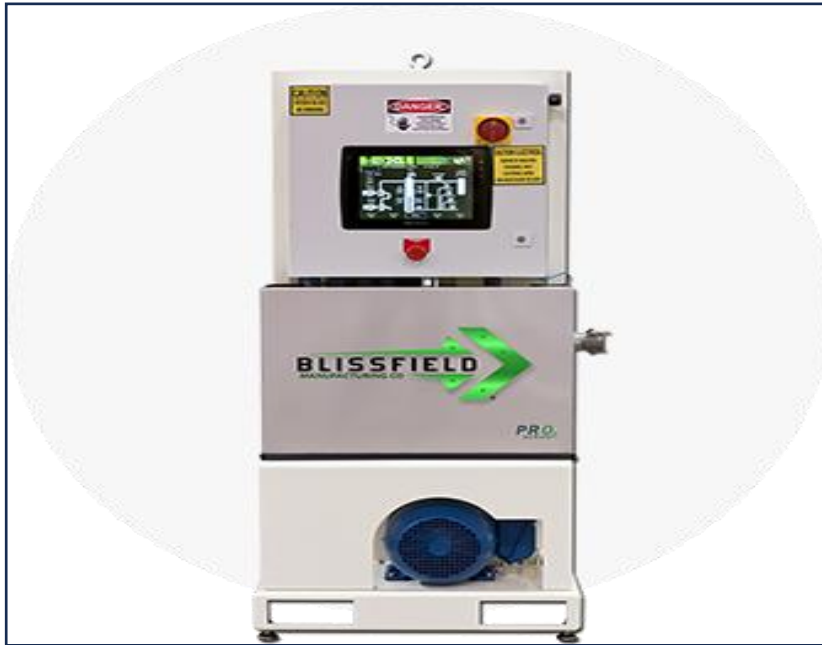
**Figure 49. Diagram of PrO<sub>2</sub> Hypolimnetic Oxygenation System.**

- Empowers Microbes to Consume 95% of Organic Waste
- 96% Oxygen Transfer Efficiency
- 75% Reduction in Conventional Aeration Costs
- Targeted Application Control (oxygenates the deep basin only if desired)
- Remote and Onsite Control Options (can maintain constant stable dissolved oxygen concentrations)
- Scalable to every lake size (includes a secure shed or trailer for large units)

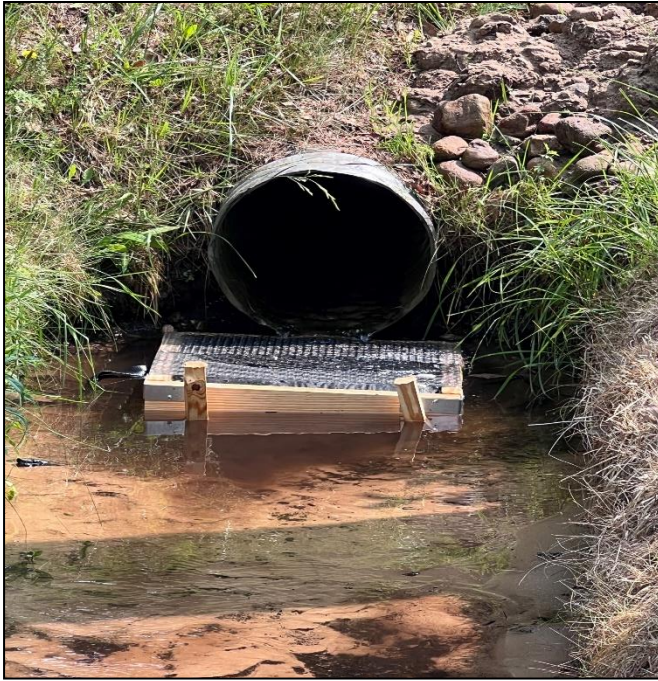
**Figure 50. Biochar filters in front of a lake drain.**

A natural charcoal technology called TimberChar Biochar® is available for filtration of nutrients and pollutants that may enter inland waters such as Crockery Lake. The Biochar is comprised of 87.4% organic carbon based on percentage of total dry mass. Particles range in size from 8-25 mm so there is inherent variability in particle size. This variability allows for the adsorption of nutrients and pollutants due to increased adsorptive surface area. Biochar may be placed in a multi-filament polypropylene sock (such as Silt Sock®) which has a life expectancy of up to 3 years. It is considered an inert product with no chemical effect on the environment. This product allows for the Biochar to be contained in an area and serves to consolidate the particles for optimum filtration efficiency. Previous data collected by RLS on an inland lake inlet that utilized the Biochar showed significant reductions in nutrients such as phosphorus and nitrogen as well as total suspended solids (Jermalowicz-Jones, 2012-2016). Additionally, another pilot project on Silver Lake in Oceana County, MI in 2023 demonstrated substantial reductions in total phosphorus, ammonia, nitrate nitrogen, and total suspended solids. The filters were applied to significant incoming drains as well as to numerous docks and boats in the lake basin. Minimal algal blooms occurred in 2023.

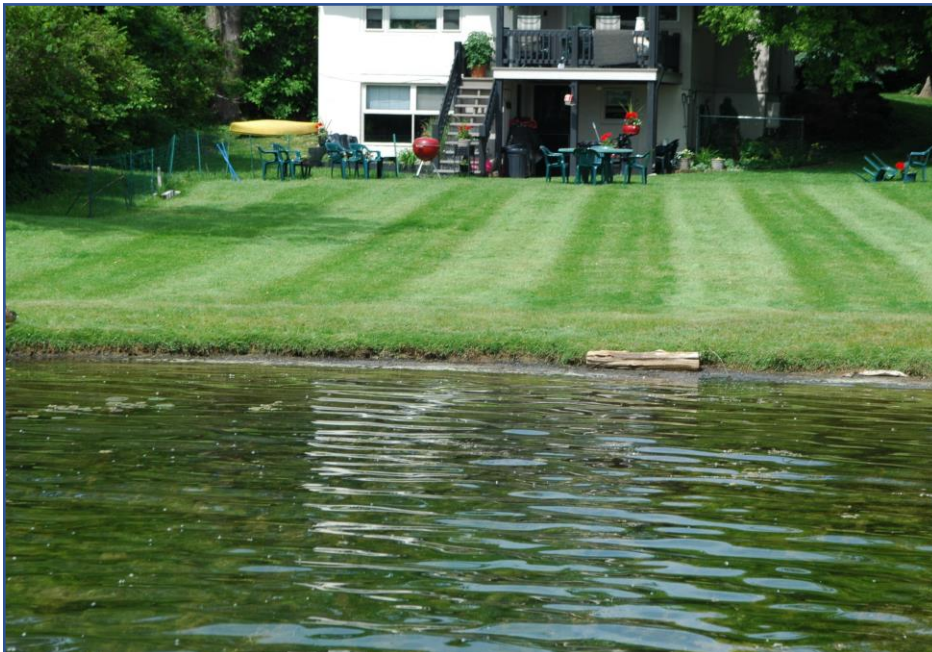
**Figure 52. A photo of a lakefront without an adequate vegetation buffer.**

- 1) Maintenance of brush cover on lands with steep slopes (>6% slope)
- 2) Development of a vegetation buffer zone 25-30 feet from the land-water interface with approximately 60-80% of the shoreline bordered with vegetation (Figure 52 is an example of a lack of riparian buffer)
